# Manhole Inspection Summary

Manhole # S19QQ\_011MH

**Location** Address: **3515 LIBERTY HEIGHTS-WESTBURY** Cross Street: **WOODBROOK AVE**

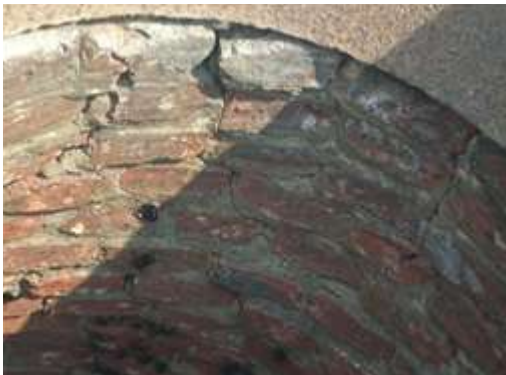
Defect 2

Condition: ☐ Sound ☐ Cracked ☐ Root Intrusion ☒ **Loose Brick** ☐ Deteriorated

LOOSE BRICK CORBEL

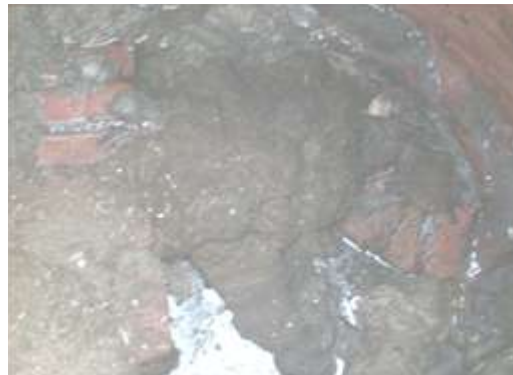
Defect 3

DEBRIS IN CHANNEL

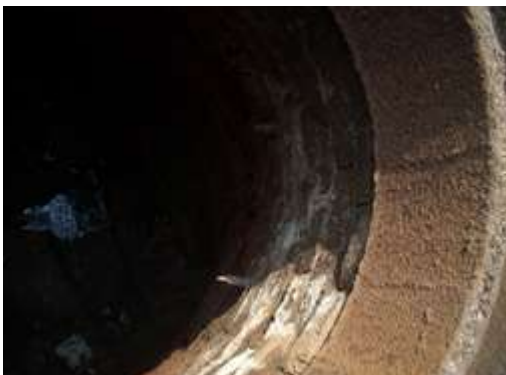
Defect 1

**Steps** Count: **0** Missing: **2** ☐ Corroded

MISSING STEPS

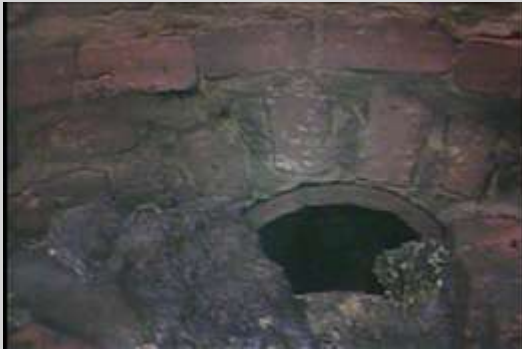
12 O'Clock Outflow

8 in. Circular Gravity Sewer  
Pipe Out @ 12 O'Clock

Pipe Height: **8.4** (in.) Rod and Bar (Angled)  
Pipe Material: **Clay** ☐ Pipe Lined  
Invert Depth: **6.90** (ft.) Flow Characteristics: **None**  
Deposits: ☐ None ☒ **Mud** ☐ Sludge ☐ Debris ☐ Grease  
Silt Depth: **5** (in.) Deposits Extent: **Heavy**  
Infiltration: **None** Pipe Seal Cond: **Sound**

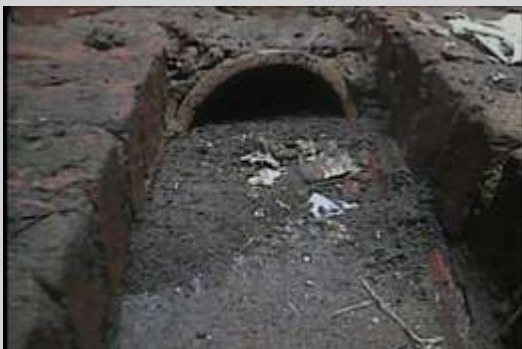
4 O'Clock Inflow

6 in. Circular Gravity Sewer  
Pipe In @ 4 O'Clock

Pipe Height: **6** (in.) Rod and Bar (Angled)  
Pipe Material: **Clay** ☐ Pipe Lined  
Invert Depth: **6.39** (ft.) Flow Characteristics: **None**  
Deposits: ☐ None ☐ **Mud** ☐ Sludge ☒ **Debris** ☐ Grease  
Silt Depth: **4** (in.) Deposits Extent: **Medium**  
Infiltration: **None** Pipe Seal Cond: **Sound**
